**Report For:**  
Wildwood Property Association  
Tolland, Massachusetts

# CRANBERRY AND OTTER PONDS Field Assessment - 2021

**Prepared by:**  
**Aquatic Restoration Consulting, LLC**  
18 Sunset Drive  
Ashburnham, MA 01430

*November 2021*

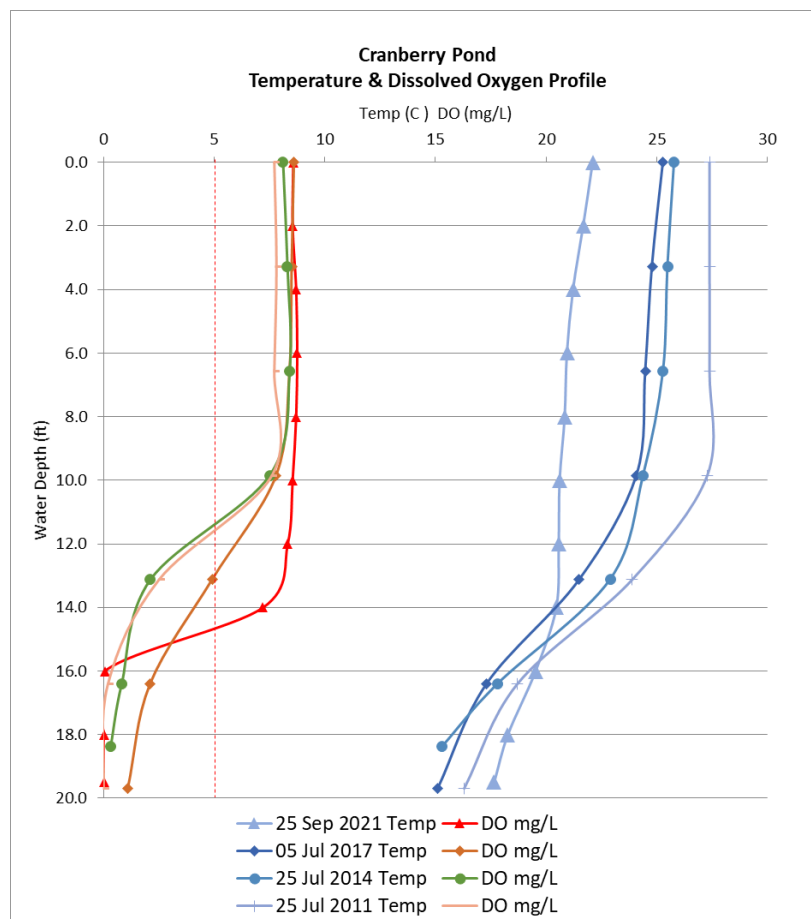
**Figure 3. Cranberry Pond Temperature and Dissolved Oxygen Depth Profile.**

Cranberry Pond is thermally stratified with the thermocline (boundary between upper, warmer, well lit layer and lower, colder, darker layer) present at approximately 3.5 meters (m) or 11.5 feet (ft) during the summer months. In 2021, the pond was not stratified during the survey because it was conducted later in the season when the lake started to turnover (i.e., mix)(Figure 3). Oxygen was depressed at the thermocline and hypoxic (low) to anoxic (no oxygen) in 2011, 2014 and 2021 at depths greater than 16 feet (Figure 3). The survey in 2017 did not exhibit anoxia and was conducted about 20 days earlier in the summer than previous July surveys. The bottom water layer covers only 10-15% of the lake bottom and represents only 3-4% of the lake volume (about 30 out of 900 acre-feet of water). With an average depth of about 12 ft, most of the 75-acre lake will not experience oxygen problems, but the deepest portion does experience low to no oxygen. Waters containing dissolved oxygen above 5.0 milligrams per liter (mg/L) are considered supportive for aquatic life, in accordance with Massachusetts State Water Quality Standards. In the absence of oxygen, certain undesirable chemical compounds will accumulate in the bottom water layer, most notably dissolved and particulate phosphorus, iron and manganese, ammonia, and possibly hydrogen sulfide.

2. The organic bottom sediments generate an oxygen demand that cannot be met by oxygen reserves where the ponds are deep enough to thermally stratify. That is, where a deeper water layer is created and stable for the summer, it will lose its oxygen and become “anoxic.” This occurs in Cranberry Pond, but not in Otter Pond, as the latter is not deep enough. This limits fish distribution and encourages release of certain undesirable compounds from deep sediments. Impacts on Cranberry Pond have not been severe, and this condition is largely natural (observed in most area lakes), but is not desirable. Installation of a mixing or oxygenation system would counter any impacts but may not be justifiable at this time.

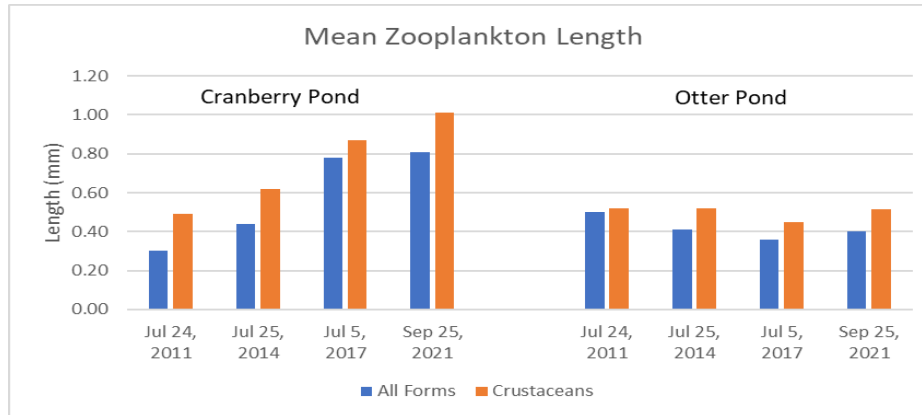
**Figure 7. Mean Zooplankton Body Length - All Assessment Years**

Average (mean) crustacean zooplankton length in 2021 was 1.01 millimeters (mm) in Cranberry Pond, twice as large as the average length in Otter Pond (0.51 mm) (Table 7, Figure 7). Prior year mean crustacean zooplankton length in Cranberry Pond was 0.49 mm in 2011, 0.62 mm in 2014 and 0.87 mm in 2017. The mean length has increased over time. Mean lengths between 0.4 and 0.8 mm indicate a balance between growth and predation, with smaller means suggesting intense predation and larger ones suggesting low predation. These data suggest that predation pressure has decreased in Cranberry Pond over time.

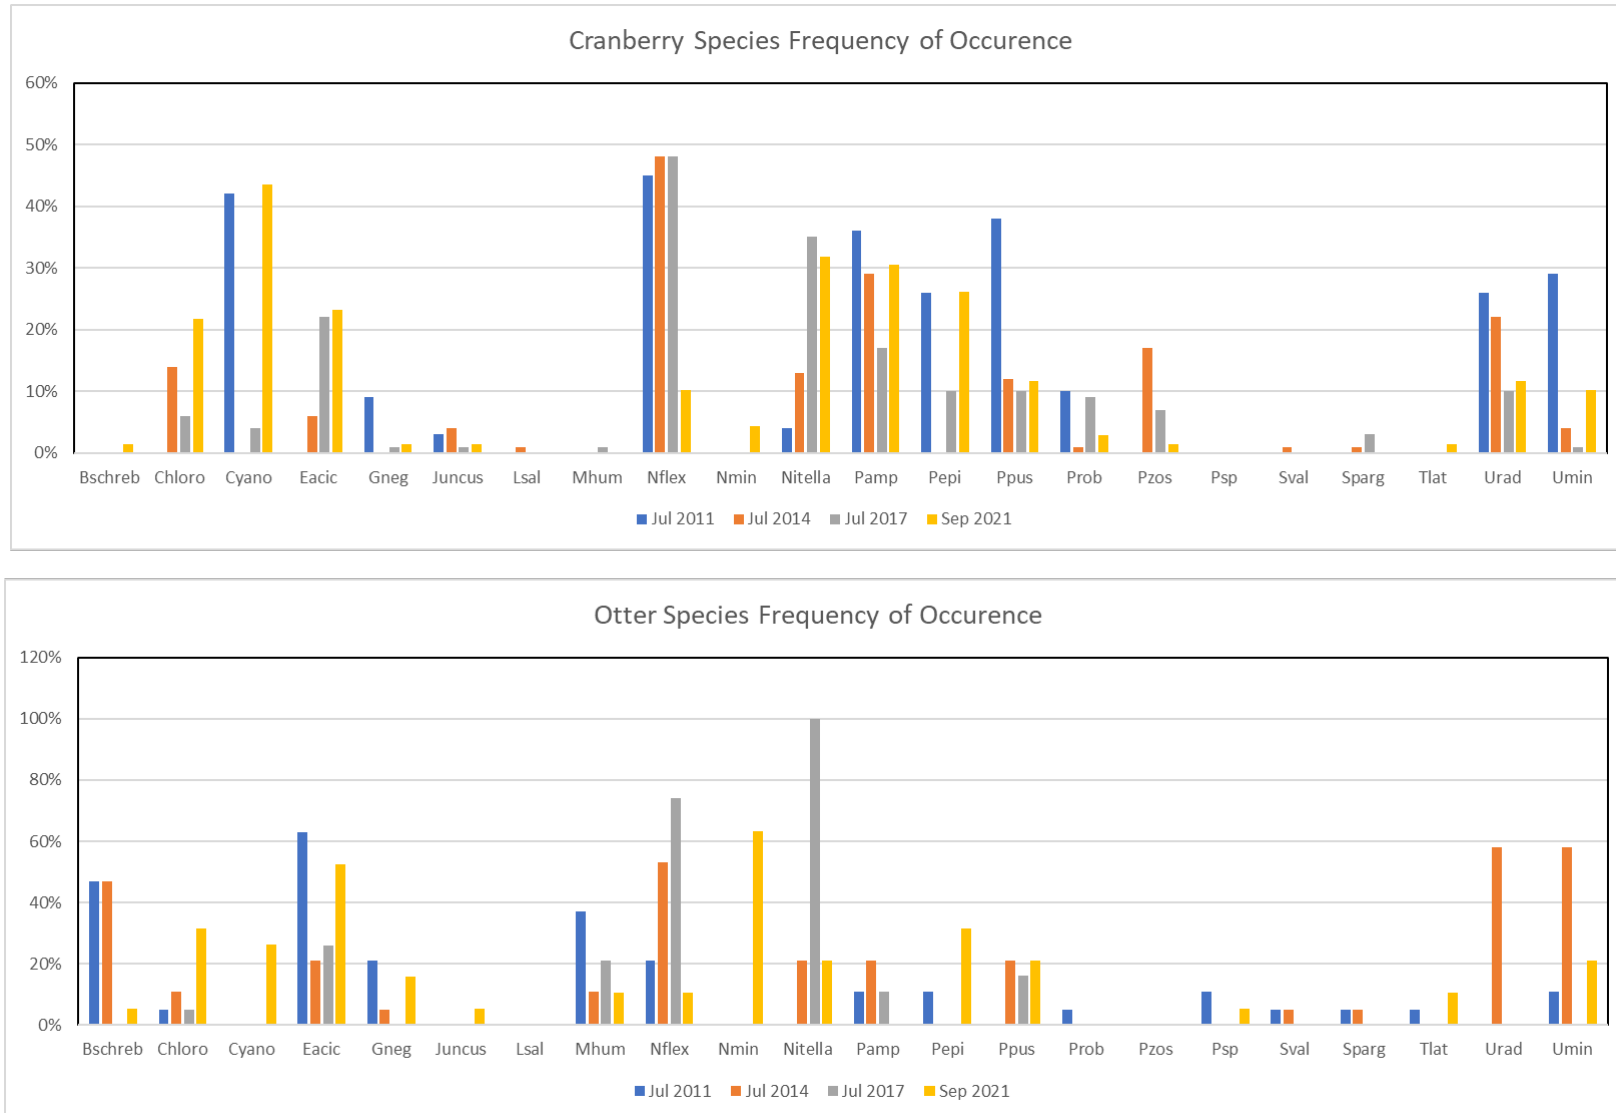
**Figure 10. Macrophyte Frequency of Occurrence - All Assessment Years**

The most frequently observed species (not including algae) in Cranberry Pond in September 2021 were native pondweeds: big-leaved pondweed (*Potamogeton amplifolius*, at 30% of sites) and ribbonleaf pondweed (*P. epihydrus*, at 26% of sites). The non-native, brittle naiad, was observed at 4% of the observation locations (three locations). Also abundant were cyanobacteria mats (43%) and *Nitella* (32%). True rooted plants grow to a water depth of about 12 feet in Cranberry Pond and cyanobacterial mats can be found at the deepest depth (>20 ft). Changes greater than 15% in frequency of occurrence from 2017 data suggest that there were more algae (cyanobacteria and chlorophyta), ribbonleaf pondweed (*P. epihydrus*) and less common naiad (*Najas flexilis*) in Cranberry Pond (Figure 10).

The most frequently encountered plants in Otter Pond were brittle naiad (observed at 63% of the survey locations) and spikerush (*Eleocharis acicularis*; observed at 53% locations)(Figure 10). Algae and ribbonleaf pondweed were observed at about one third of the sites. Watershield (*Brasenia schreberi*) has apparently achieved nuisance levels in Otter Pond in the past, and hand-pulling has been conducted, but watershield was not abundant at the time of the September 2021 survey. It is unknown, as of the writing of this report, whether management activities for watershield were performed in recent years and has resulted in lower biovolume.

Otter Pond's plant community in 2021 was less similar to 2017. Data suggest that Otter Pond contained much more (>25% increase) cyanobacteria, chlorophyta, spikerush, ribbonleaf pondweed in 2021 than in 2017. The most striking difference was the introduction and distribution of brittle naiad, which was the most frequently encountered plant in 2021, but this plant was not observed in any of the prior year surveys. There was substantially less common naiad and *Nitella* in 2021. Minor changes in the plant community year to year are expected due to natural variability. More drastic shifts are generally associated with extreme weather conditions or introduction of new species. The introduction of brittle naiad has likely impacted abundance of native common naiad and potentially *Nitella* in Otter Pond.

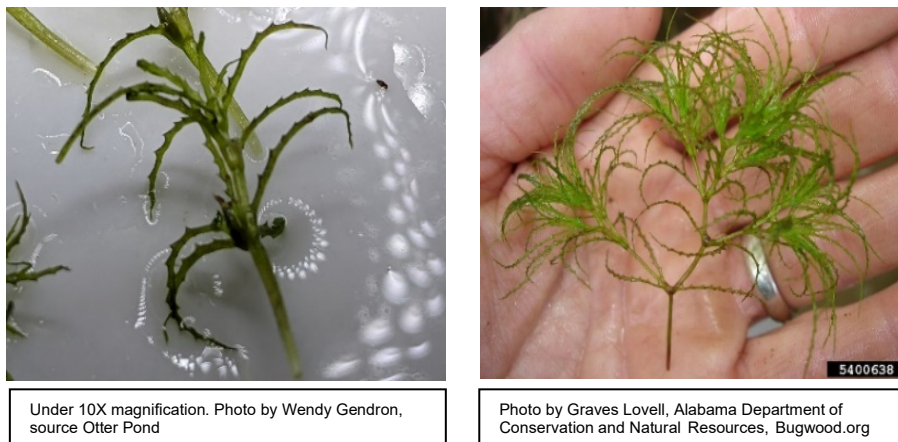
**Figure 11. Brittle Naiad Photos**

As mentioned previously, non-native brittle naiad (native to Europe, western Asia and northern Africa) was identified this year. It is not known when it arrived. Introduction of brittle naiad into these ponds are likely from waterfowl or unintentional human transfer (recreation equipment – trailers, boats, fishing equipment etc.). If the plant becomes problematic, management in the future may be warranted. Brittle naiad can grow over eight feet high depending on water clarity and can form a dense monoculture (large growth area of single plant species) reducing the plant community diversity and decreasing aquatic habitat quality. Sometimes, however, this plant can co-exist within the waterbody without growing to great heights or become a nuisance. This plant reproduces primarily by seed but can also spread by fragmentation. Because it is an annual plant, it requires seed germination to survive year to year. It is tolerant to turbid eutrophic conditions. Plant management control measures for this species is generally limited to chemical treatment or benthic barriers in small areas (docks, beach, etc.). Additional information regarding this species can be found in Appendix B.

Identification of different naiad species can be difficult in the field in absence of seeds or without magnification which is required to see leaf base morphology. This plant produces flowers in July and seed production peaks in September. Seeds were not likely present during the July previous surveys. ARC collected representative specimens in September 2021 and viewed plant structures under magnification back at the office to confirm the identification of brittle naiad. Key identification features of this plant include a “toothed” appearance on the thin stiff leaves that curl resulting in a bushy form and shape of the leaf base seen under magnification.

5. Annual plant surveys are recommended, partly to detect any new species and partly to establish any trends in changes in coverage and biomass. Brittle naiad is a possible threat to both habitat and recreation, but it also could co-existing without issue. Annual plant surveys are recommended to track its spread. If plant density is higher than lake users would prefer, localized methods of control may be appropriate. These would include mainly hand harvesting (with mechanical aids as warranted, including rakes) but care must be taken to remove any brittle naiad fragments created to prevent distribution of this non-native in the lake. Bottom barriers that cover selected small areas are a better solution as this does not create plant fragments and will prevent naiad seeds from germinating.

6. Notification of brittle naiad presence should be posted at the public use areas at both ponds and caution the public about the potential to transport this species to other lakes.

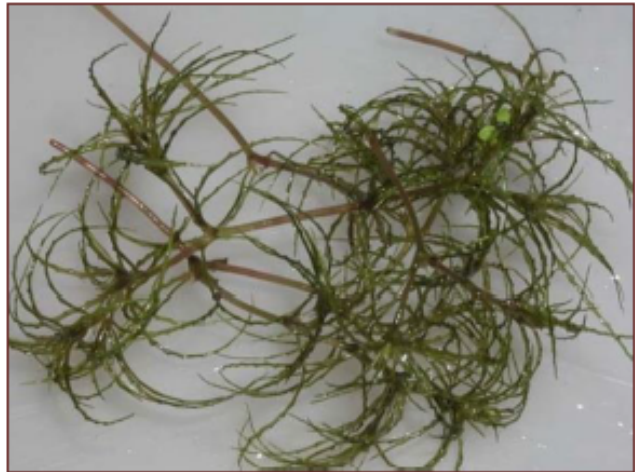
Brittle Naiad (*Najas minor*)

Brittle naiad is a submerged aquatic plant with substantially branched stems that easily fragment. The leaves are curled, recurving (curled backwards) with age, and approximately one inch long with a noticeably serrated leaf-edge. The branching and curled leaves give brittle naiad a bushy appearance.

Brittle naiad can grow to a length or height of approximately 2.5 meters. Tiny flowers are produced in the leaf axils, which fertilize and mature into oblong seeds. Brittle naiad also reproduces and spreads with auto- and artificial- fragmentation. The plants are annual, not persisting past late fall, and depend on seed germination for continual infestation. It can form dense shoals and surface mats in water 12 feet deep. Brittle naiad is often confused with coontail, native naiad, and some macroalgae, such as *Chara*. Native naiad can be distinguished through its thicker, broader leaves.
