Management Plan
For
Cranberry & Otter Ponds

WILDWOOD
PROPERTY OWNERS ASSOCIATION, INC.

POND PRESERVATION COMMITTEE

Second Edition

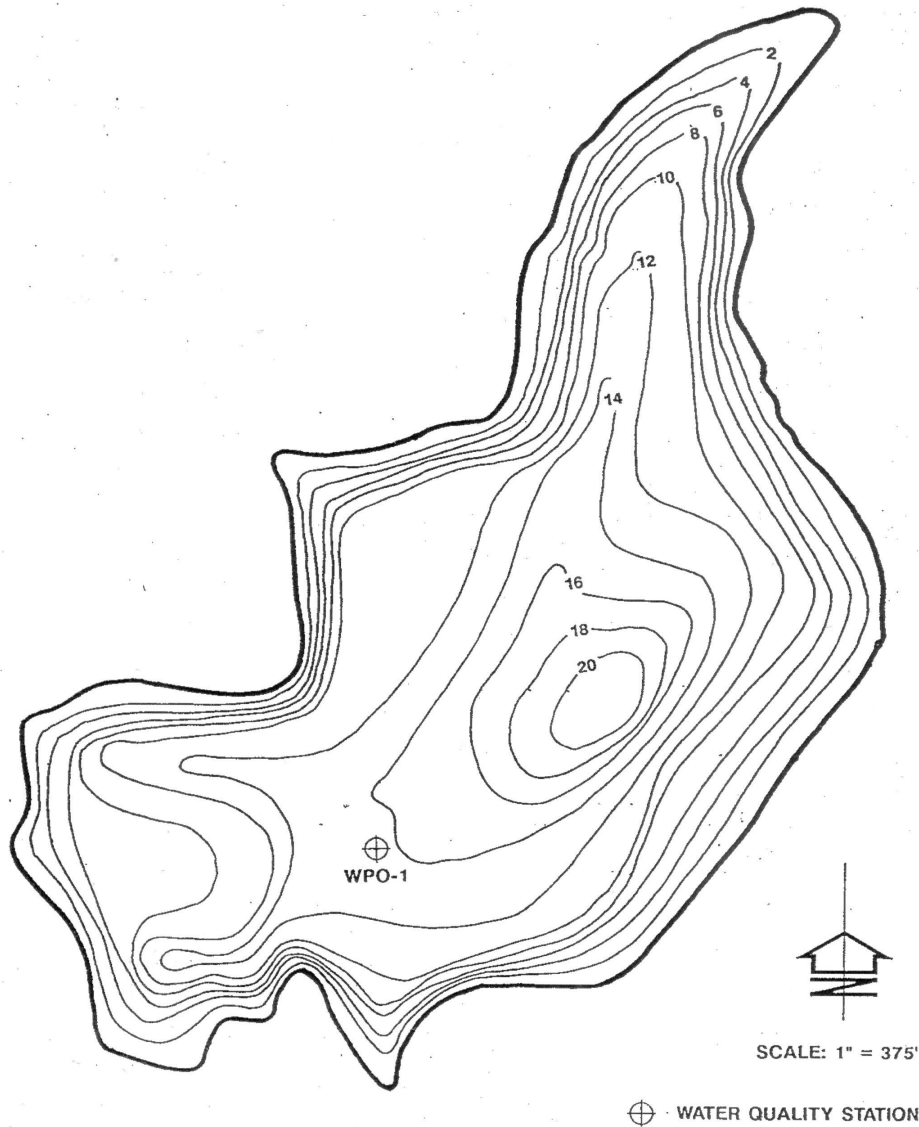
FIGURE 4
CRANBERRY POND BATHYMETRIC MAP
(CONTOURS IN FEET)

This map of CP is from the diagnostic study conducted by Baystate Environmental Consultants of East Longmeadow MA in 1992.

map the bottoms of both ponds at Wildwood with the newest technology. The 2016 map for CP is seen on the page following the map from 1992.

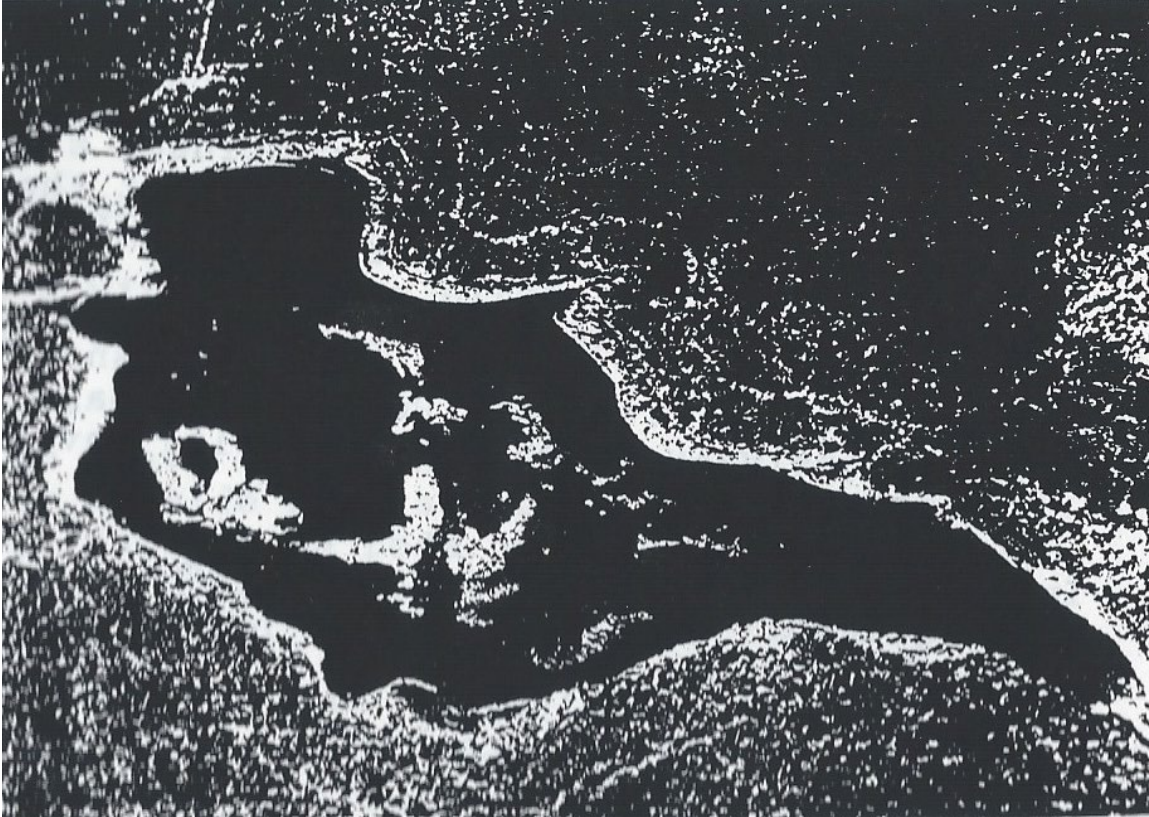
An aerial view of massive floating islands in CP in 1970

Two points need to be recognized concerning management of today’s floating islands. First, their physical removal is costly and dangerous; during past, removal efforts, winched chains or cables attached to the islands have snapped as the tension upon them was increased. And second, removal does not guarantee that other islands will not appear in subsequent seasons, originating from different areas of the pond bottom. For the free-floating bog mats, on the other hand, we should continue our practice of moving them close to accessible collection areas near Lakeside Beach and Meadow Beach during the summer season and then removing them once drawdown is complete and the ground has frozen. It is encouraging that during the summer seasons since 2013 noticeably fewer floating islands appeared than in the preceding summers. If this trend continues, we may be witnessing the end of Mother Nature’s decomposition work.

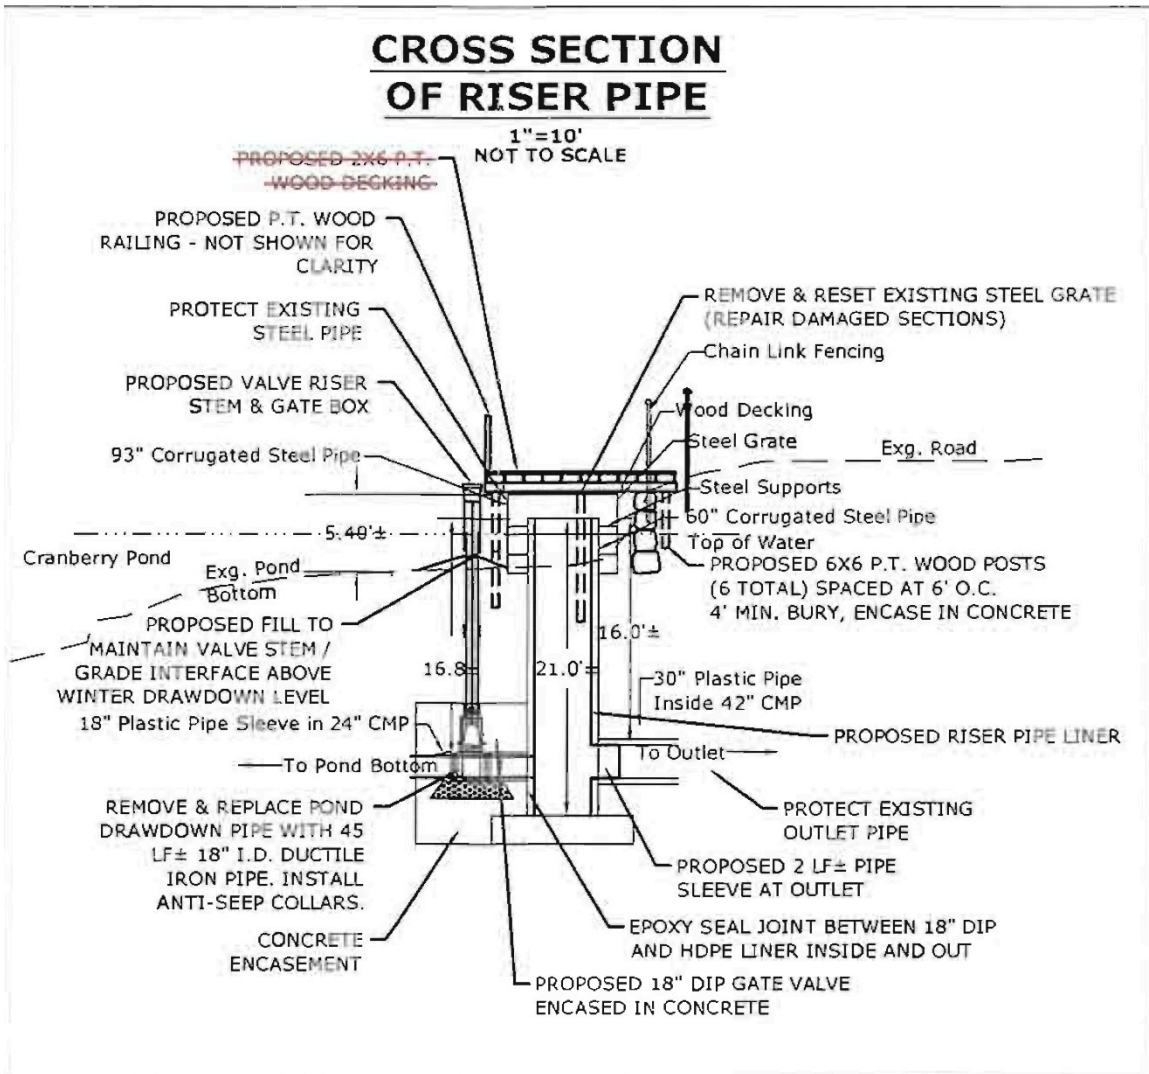
Detail of the overflow riser and gate valve of CP dam.

By 2010, the overflow riser was in need of slip lining, and because a portion of the intake pipe had collapsed, the opportunity to design an entirely new intake pipe and valve configuration was taken. The dam repairs done in 2011 (under NOI/ OOC [DEP File Number] 306-0049) incorporated these modifications as seen in the accompanying diagrams. A new iron inflow pipe, supported on a bed of concrete, replaces the old corrugated metal intake pipe. The intake end of the new pipe is fitted with an elbow opening to the pond floor and covered with a metal basket to prevent debris and large fish from entering the intake. A new gate valve is installed at the end of the intake pipe nearest the base of the overflow riser allowing operation of the valve from directly above (diagram on next page). The repairs included slip-lining the overflow riser and upgrading the grating and fencing at the top of the overflow riser.

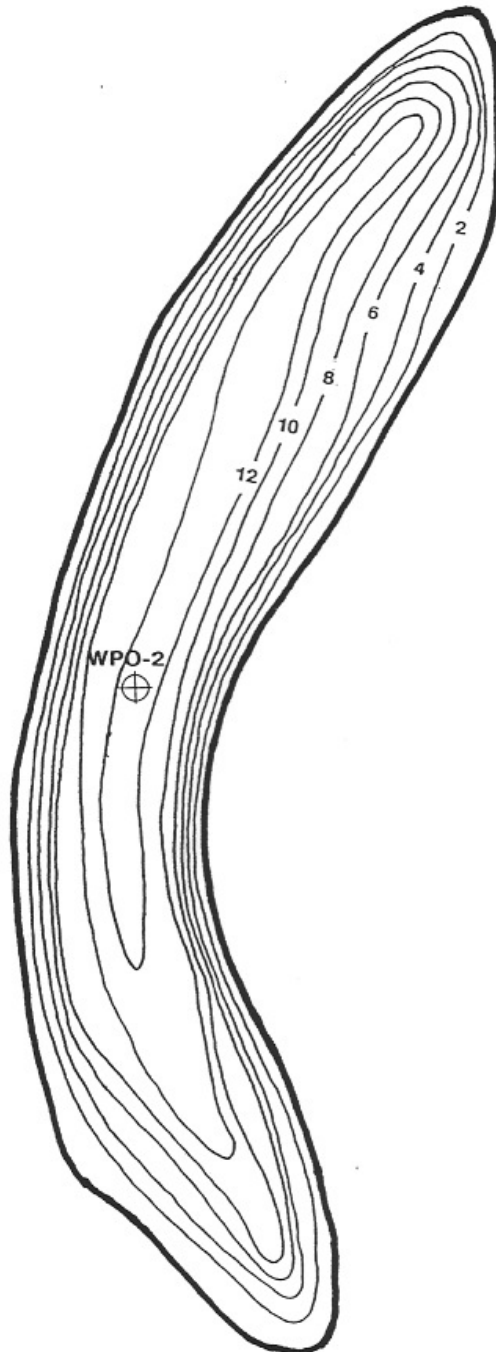
OTTER POND BATHYMETRIC MAP
(CONTOURS IN FEET)

This bathymetric map of OP is from the diagnostic study conducted by Baystate Environmental Consultants of East Longmeadow MA in 1992.

Bathymetric maps of OP generated by the procedures discussed for CP in Section 4.1 are provided on the pages that follow.

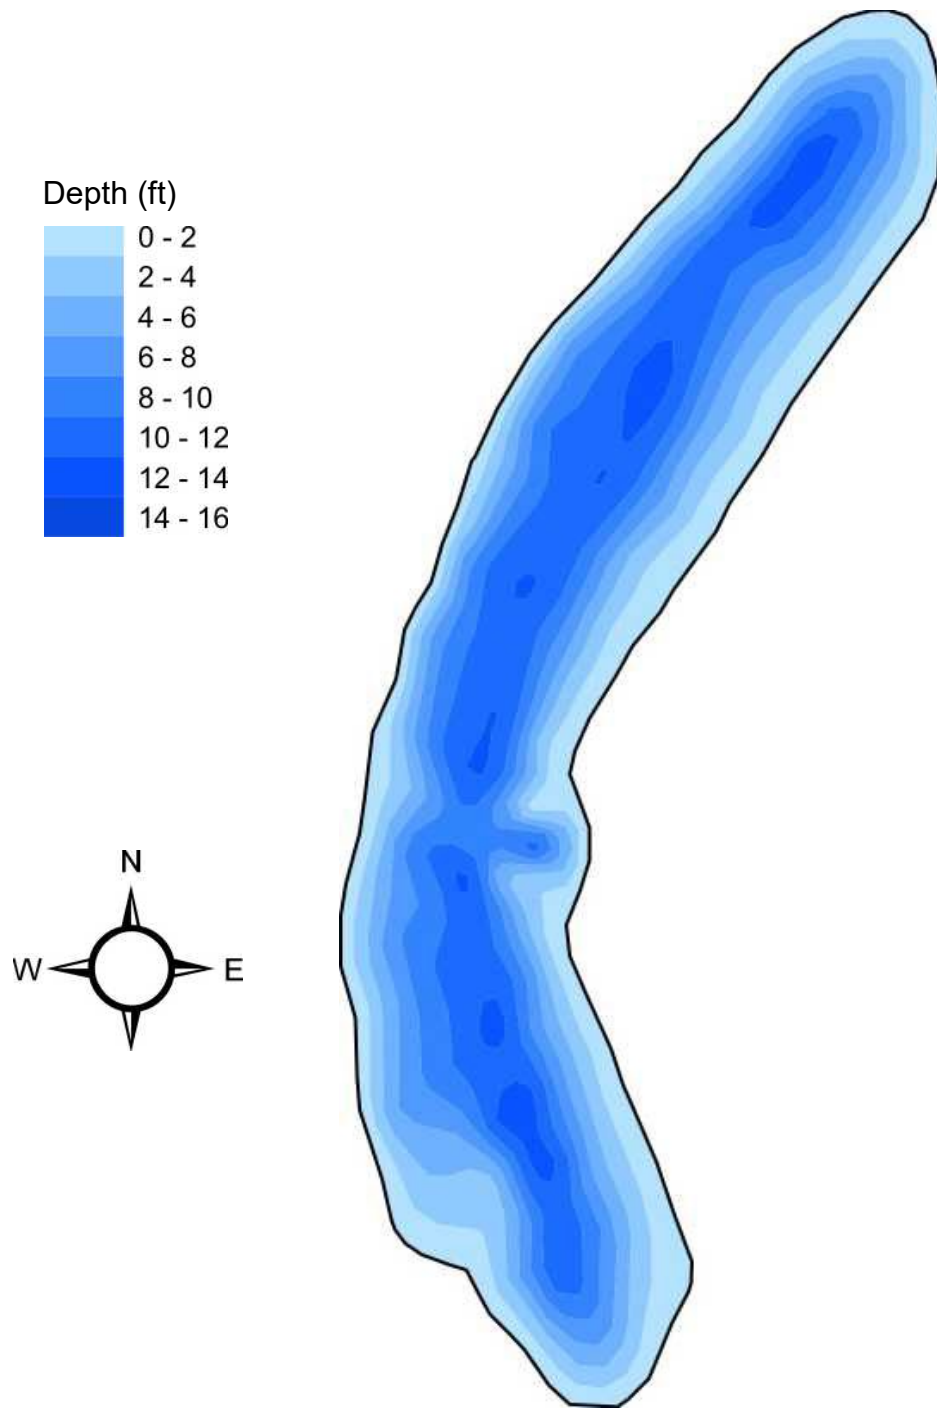
A bathymetric map of OP is based upon sonar and GPS data collected by Solitude Lake Management of Spencer MA in 2016.

The figures for OP size, volume, and depth (both maximal and average) presented at the beginning of this Section are based upon the recent bathymetric study by the Solitude Lake Management. The study data also allow the following calculations that will be referenced in Sections on aquatic plants (Sections 6.3.1 and 7.4) and drawdown (Section 8.2).

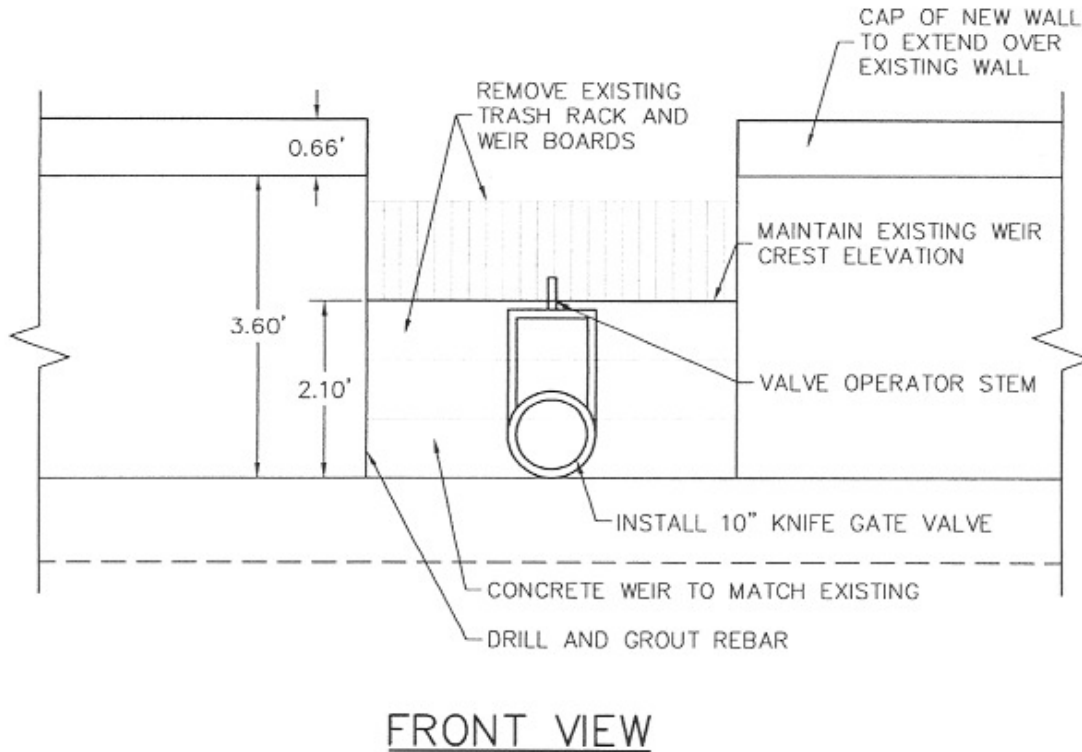
Original plan for the new OP dam; in the version that was built, the outflow pipe and gate valve were located in the left wall adjacent to the spillway.

A spillway crest centrally located along the length of the original dam featured three removable horizontal wooden weir boards to control the depth of the pond. Over time, a vertical crack developed in the dam structure, and a portion of the dam shifted. Attempts to seal the crack were made, but the more significant issue was that the dam to the right and left of the spill crest was no longer in alignment. This trapped the weir boards rendering them immobile. As a consequence, drawdowns of OP were not possible for several years.

In 2006 the dam was repaired under NOI/OOC (DEP File Number) 306-0022, and a valve was installed to allow drawdown. During this repair, it was found that the footing of the original structure had not been poured into a form but rather into an irregular trench. Furthermore the concrete was not reinforced. For the repair, the spillway, the entire right wall (looking downstream) and 12.8 ft of left wall were demolished, a frame of steel reinforcement bar was constructed, and concrete was poured to generate a structure that was mostly new. But first a new footing was established to provide for maximal drawdown capability based on the elevation of the downstream channel. The new spillway is 4.35 ft wide with its height matching the height of the previous weir boards (*i.e.*, 3.9 ft above the height of the new footing). Walls, 12.8 ft in length, were poured on either side of the spillway. To the left of the spillway (looking downstream), the new concrete was matched to the portion of the original dam that had not been removed. A 10 inch knife valve and a PVC outflow pipe originally planned to be centered at the bottom of the spillway wall (see diagram) was actually installed in the left wall immediately above the footing and adjacent the end of the spillway wall to provide easier operation of the gate valve from above. Most of the outflow side of the wall flanking the spillway was backfilled to provide additional support.

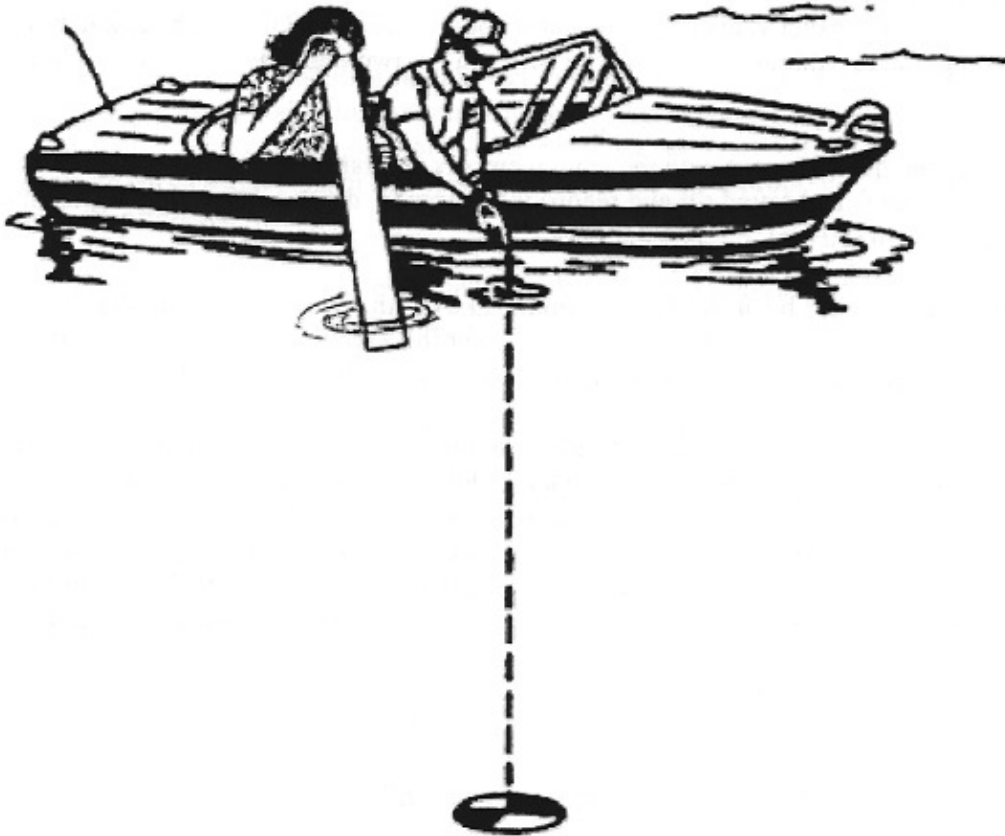
TAKING A SECCHI DISK MEASUREMENT

A Secchi Disk measurement aided by a viewscope.

Secchi measurements are most consistent when done by the same volunteer and following a standard routine. Viewscopes are better than sunglasses or polarized lenses for minimizing the influence of glare. Various sources recommend that readings be made between 10AM-4PM, 10AM-2PM, or 9AM-3PM.

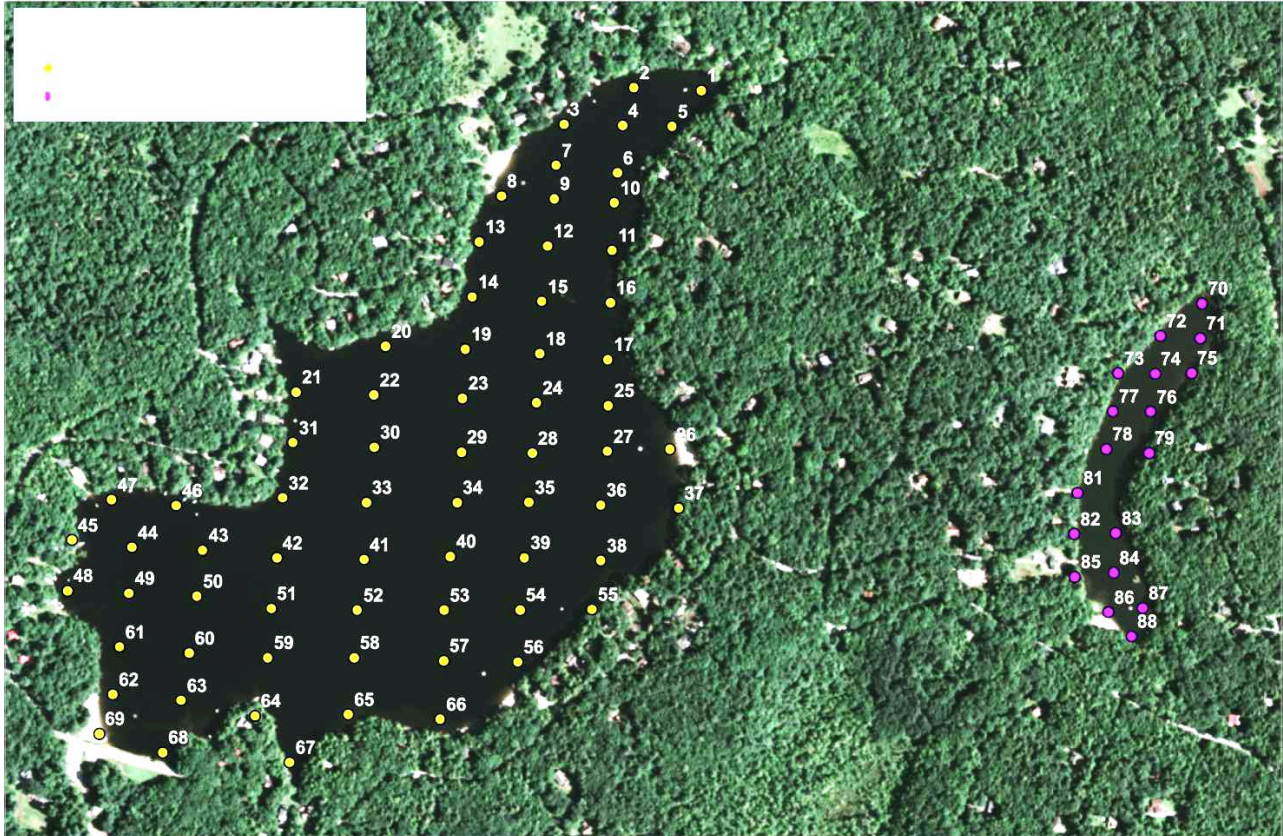
Satellite view of Wildwood Ponds showing locations of points examined during the aquatic plant survey conducted by Water Resource Services. Point 80 has been inadvertently omitted from Otter Pond.

points on the bottom was considered a representative sample. The OP study examined 19 grid points. The locations of these points are shown in this map.
